Observations of Structural Damage Caused by Hurricane Katrina on the Mississippi Gulf Coast

OBSERVATIONS OF STRUCTURAL DAMAGE CAUSED BY HURRICANE KATRINA ON THE MISSISSIPPI GULF COAST

Subject Headings: hurricane, storm surge, wind gust, wind load, structural failures, damage, damage assessment, Mississippi

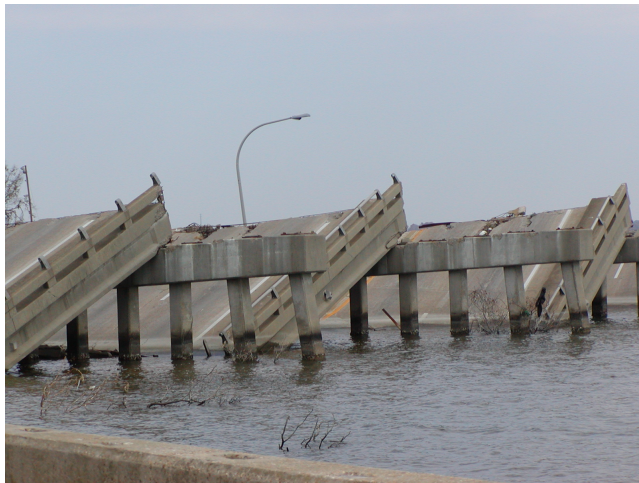
Constructed as a 2.4 km, 4-lane prestressed concrete highway bridge, the Biloxi Bay Bridge was part of US 90 and connected Biloxi to Ocean Springs (Fig. 1.) All of the spans of the bridge's superstructure (i.e. deck and girders) were raised and pushed in a northeasterly direction, dropping the west side of the superstructure from the supporting pier (Fig. 2.) The piers below appear undamaged, and many of the spans are not damaged severely. The bridge girders were not constrained to the bearings (Fig. 3), and the surge simply lifted the spans from the supports. Thus it appears that connection inadequacy was the cause of failure. A significant contributing factor may be the buoyant force. Given that submerged concrete has its self-weight

Figure 2. Collapsed Spans of Biloxi Bay Bridge.

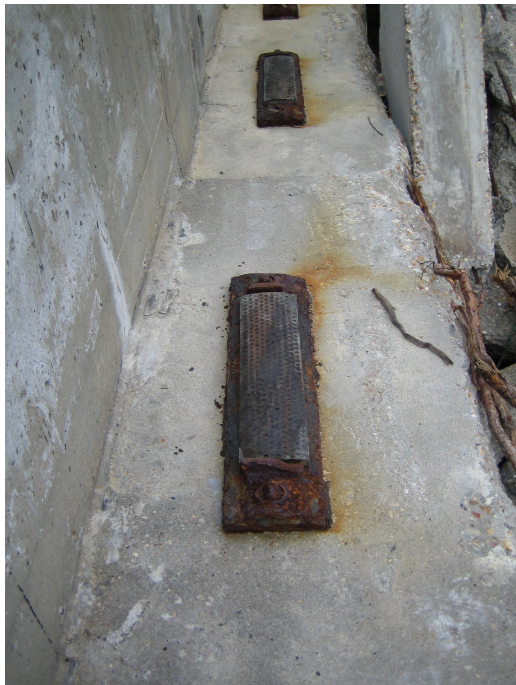
effectively reduced by over 40%, as well as the possibility of air being trapped under the deck between adjacent girders as the surge rises, the failure is not surprising. The surge also caused significant scour beneath the road on top of the abutments as well as the abutments themselves (Fig. 4.)

Figure 3. Biloxi Bay Bridge bearings show lack of adequate connection to superstructure.

failures. An investigation of bearing connection strength is recommended. Most light-frame wood structures subjected to storm surge were destroyed. It appears that most failures occurred at the fasteners. However, it is not known whether strengthened connections alone would have resulted in substantial decreases in damage, as overall structural system resistance to a lateral load such storm surge is much less than that found in the survived commercial-grade frames. An investigation to determine the desired and current design strengths is recommended, and how the gap between these can be closed. Particular attention should be paid to fastener strength.

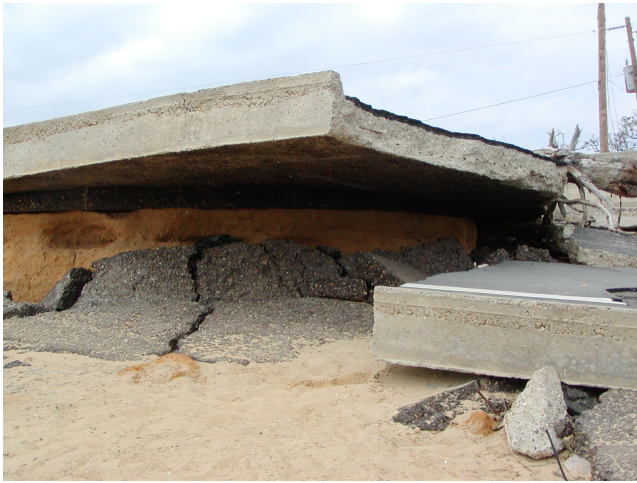
Figure 4. Biloxi Bay Bridge road undermining.

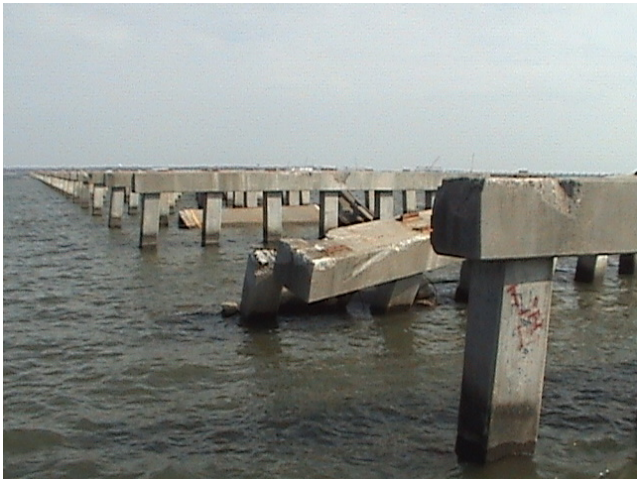
This was a 3.2 km prestressed concrete bridge that spanned from Pass Christian to Bay St. Louis (Fig. 1) This bridge lost all of its spans as they were pushed completely off of the pier supports (Fig. 5.) There was some pier damage as well. As all spans separated from the piers at the bearings and the visible spans appear intact, inadequate bearing up-lift strength was the cause of failure, as with the Biloxi Bridge. In this case, the bearing was apparently tied to the superstructure but the strength of the connection as well as its embedment into the pier was simply inadequate (Fig. 6.) Serious scour was also observed (Fig. 7.)

Figure 5. Completely displaced spans of Bay St. Louis Bridge.

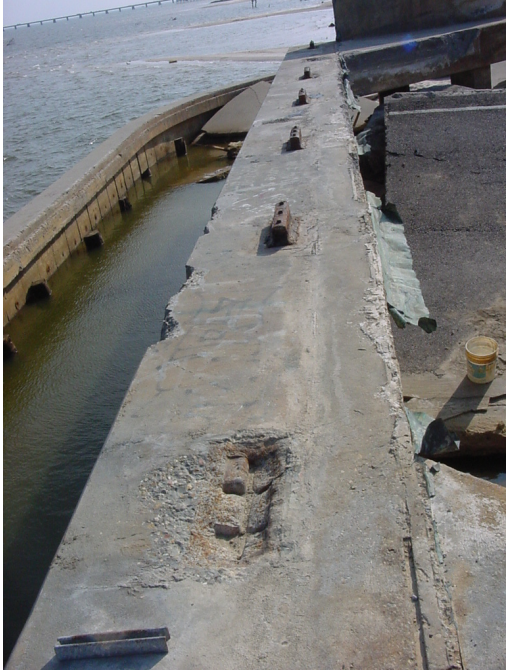
Figure 6. Insufficient connection strength of Bay St. Louis Bridge bearings.

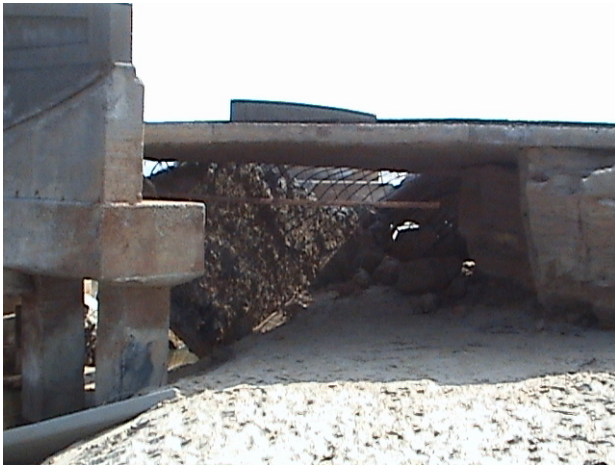
Figure 7. Bay St. Louis Bridge abutment undermining.

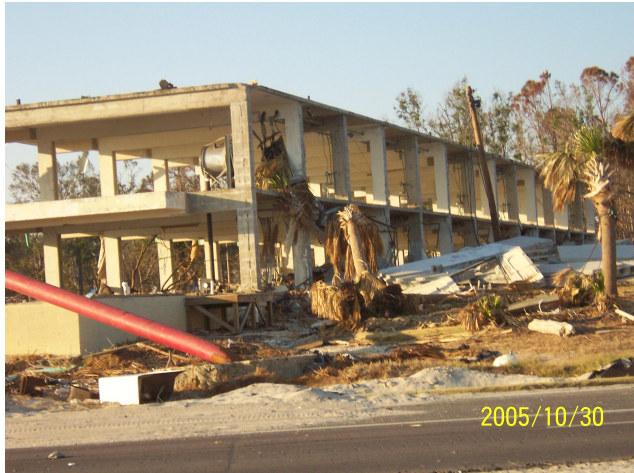
Nearly all of the reinforced concrete (RC) structural frames that were identified appeared to have performed well, with no apparent displacement, damage, or visible cracks. However, this was not the case for building façades or interior walls, as these were often significantly damaged or entirely missing from the structure if it were struck by the storm surge. Figure 8 presents a typical structurally-undamaged low-rise RC frame. Figure 9 illustrates another common RC structure on the Mississippi coast, where a slab and column system is used to support and elevate a wood structure above. In this instance, the wood structure was completely

Figure 8. Typical undamaged RC frame with destroyed façade and gutted interior.

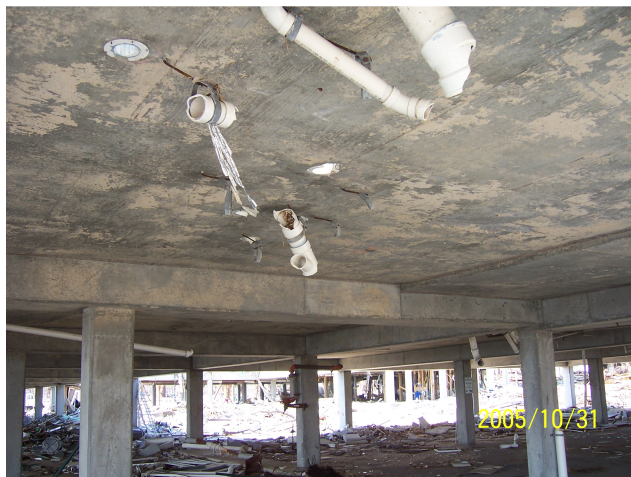
Figure 9. Underside of a typical undamaged RC frame and slab, used to support a (destroyed) wood building above.

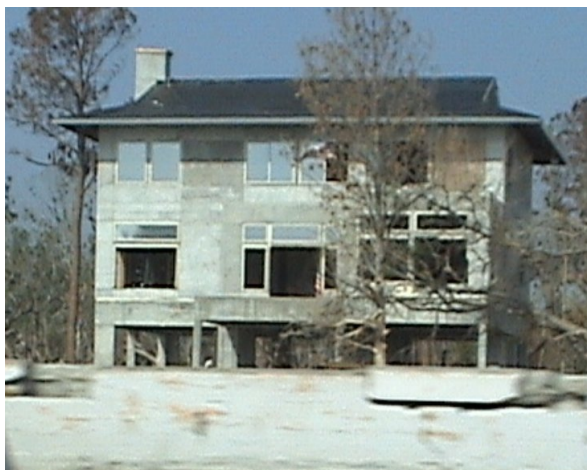
destroyed. A private residence composed of an RC frame as well as RC exterior walls sustained no apparent damage to the frame or exterior walls (Fig. 10.)

Figure 10. Undamaged RC frame and exterior wall structure (private residence).

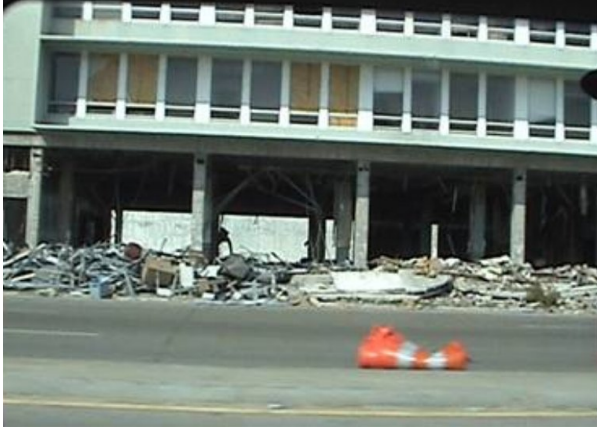
Figure 11. Typical undamaged structure of high-rise RC frame, with first floor façade and contents destroyed.

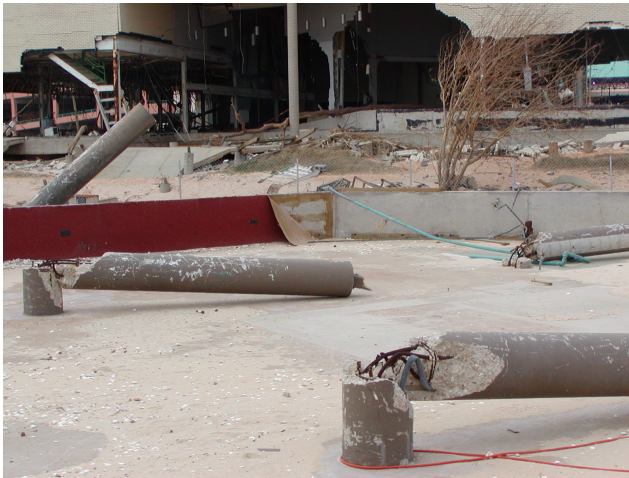
One of the two observed RC failures was the collapse of columns holding what may have been a pergola roof. These columns failed at the base, a failure which may have been mitigated if stirrups were placed in the columns to provide confinement (Fig. 12.) The other observed damaged RC building (Fig. 13) appears to have been struck by a large casino barge that washed onto the shore (not shown in the Figure), where only the impacted corner was damaged but the remainder of the structure was unaffected. The local damage appears to have been well-contained and did not visibly propagate to additional structural members. Although no additional RC failures were identified in this study, others have reported a small number of RC

Figure 12. RC failed columns.

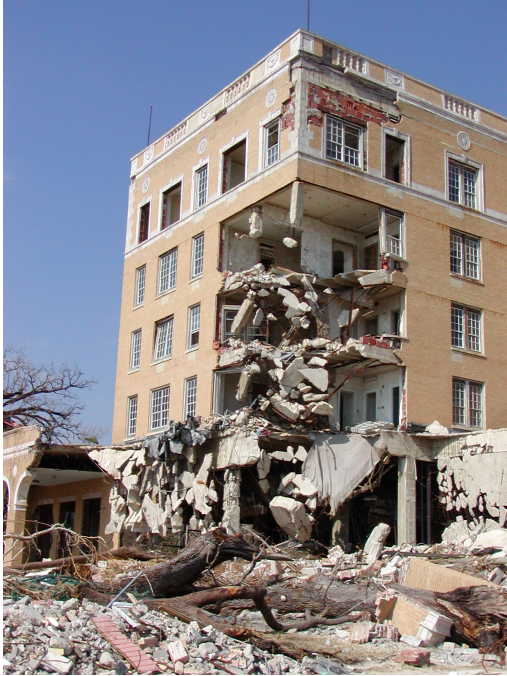
Figure 13. RC frame building struck by casino boat.

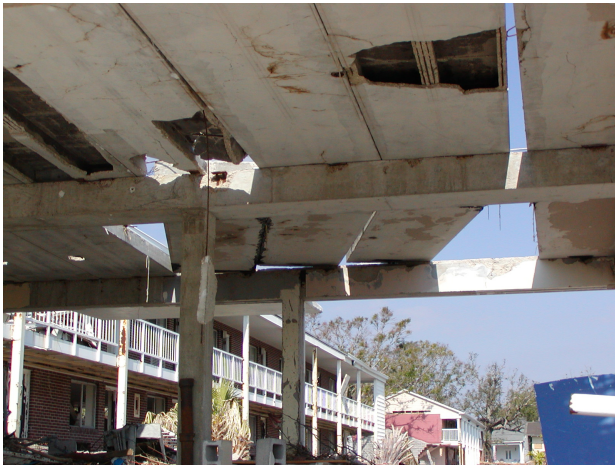
Unlike the RC structures, many of the precast concrete (PC) buildings observed sustained significant structural damage. The members themselves appear to have had sufficient capacity, however, as all observed failures occurred at the connections. Figure 14 shows an RC frame upon which PC floor slabs were placed. Although the RC frame was undamaged, the PC slabs appeared to have detached at the connections and slid to the northwest. Figure 15 shows a collapsed structure composed of PC girders supported by RC columns. This structure appears to have been used to support a wood superstructure. Here again the PC members were undamaged but failures occurred at the connections. A detail of the failed connection is shown in Figures 16 and 17. A PC pedestrian bridge is also shown to have failed at the connections (Fig. 18.) Here both girders were detached from the supporting column, and the canopy detached from the girders (which served as guardrails), with the steel connectors still visible on the top of the girders. The second floor of a PC parking structure failed (Fig. 19) when the deck T-sections were pulled from their supports on the spandrel beam. Some spandrel beams supporting the second floor also collapsed. As with the observed bridge failures, buoyancy likely was a significant factor. Here again the primary cause of failure appeared to be a lack of sufficient connection strength rather than member capacity. It should be noted that other damage surveys have identified failed PC members in parking garages, apparently due to a moment reversal caused by the surge uplift force, as occurred with the RC slab failures identified (Roberson et al. 2006). In these cases, increasing connection strength alone may not have prevented the failures.

Figure 14. Failed connections of PC slabs supported by a RC frame.

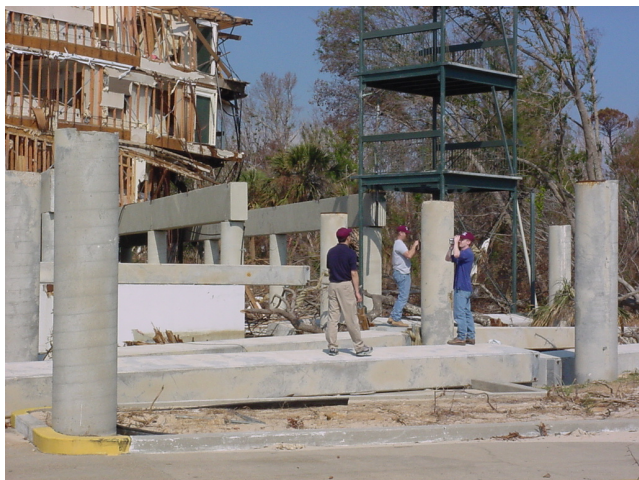
Figure 15. Collapsed PC girder system.

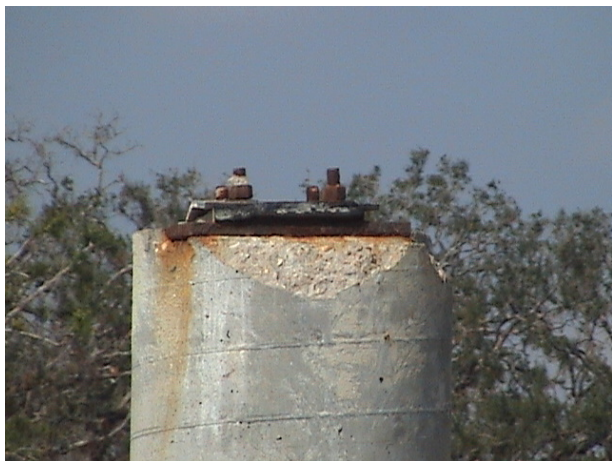
Figure 16. Failed PC column connection.

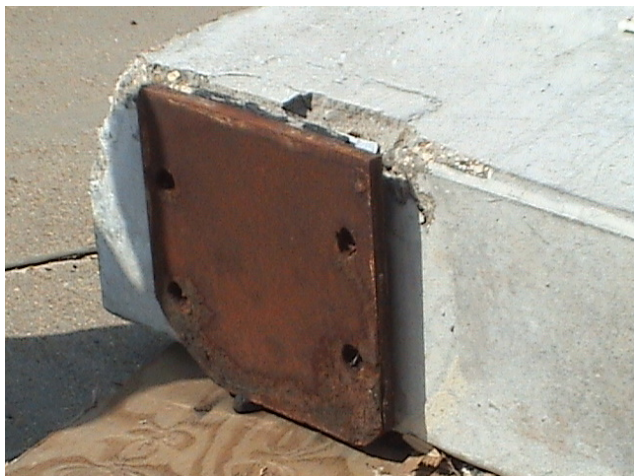
Figure 17. Failed PC girder connection.

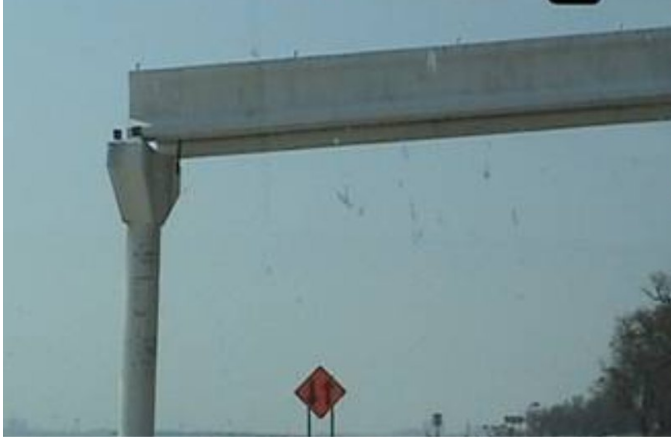
Figure 18. Failed PC pedestrian bridge. Note detachment at connections.

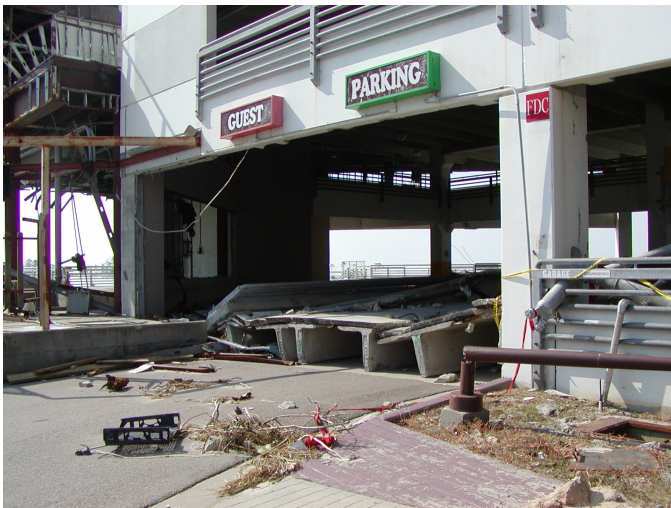
Figure 19. Collapsed T-beams of PC parking structure.

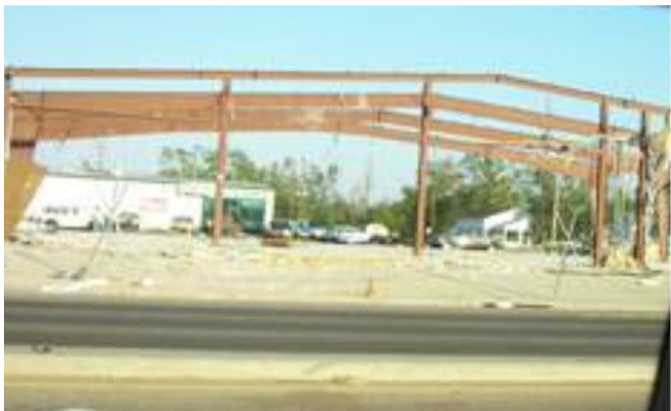
Similar to the RC structures, most steel frames appeared to have survived intact, with little or no damage. As with the RC structures, this does not include the façade and interior walls, whether made of masonry, wood, or steel studs. Figures 20-23 show typical such structures. There were some exceptions, however. Figure 24 shows a collapsed steel frame. Here the metal roof as well as the supporting purlins were bent upward, perhaps by wind, resulting in a loss of lateral stability that caused the first frame to collapse inward. Open web steel joist construction did not perform as well as wide-flange or built-up steel frame construction, a structural type for which several failures were observed. Figure 25 illustrates such a collapse. Here it appears that the far wall was toppled by the surge, causing the roof to collapse. Based on failures similar to those shown in Figure 24, as well as the observation that most steel frame failures occurred for structures with relatively slender members, it appears that the primary area of concern for the performance of steel structures under hurricane loads is stiffness and lateral stability rather than insufficient member capacity.

Figure 20. Typical survived steel frame, with façade and interior contents removed by storm surge.

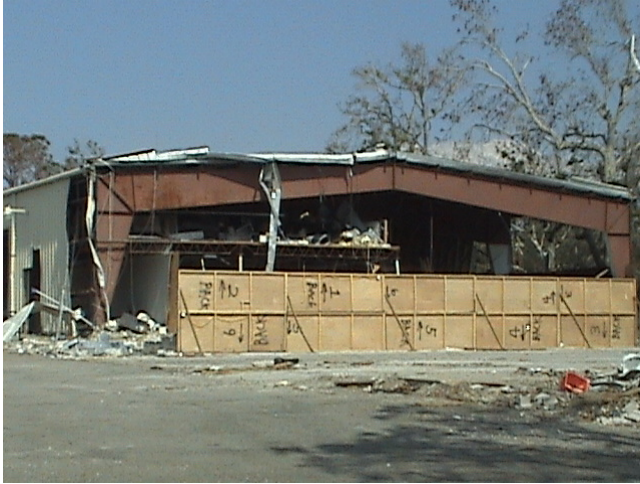
Figure 21. Typical survived steel frame.

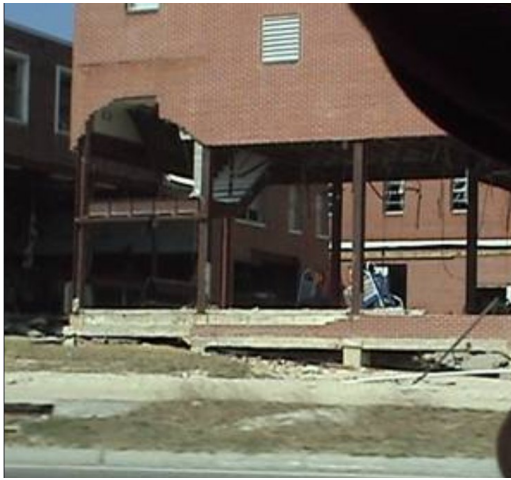
Figure 22. Typical multi-story survived steel frame.

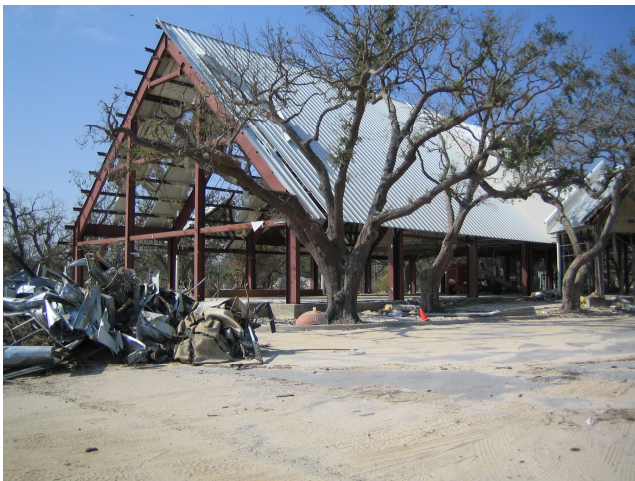
Figure 23. Survived steel frame.

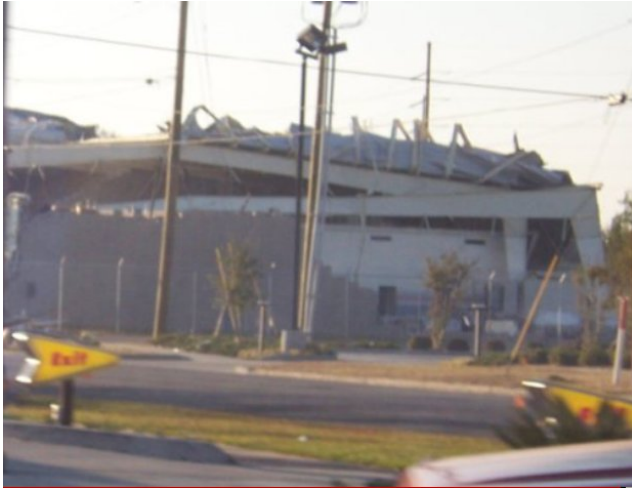
Figure 24. Steel frame lateral stability failure.

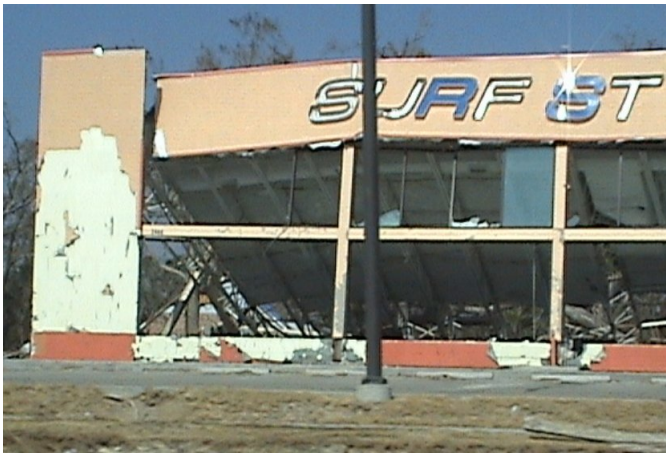
Figure 25. Failed steel frame with open-web joist roof.

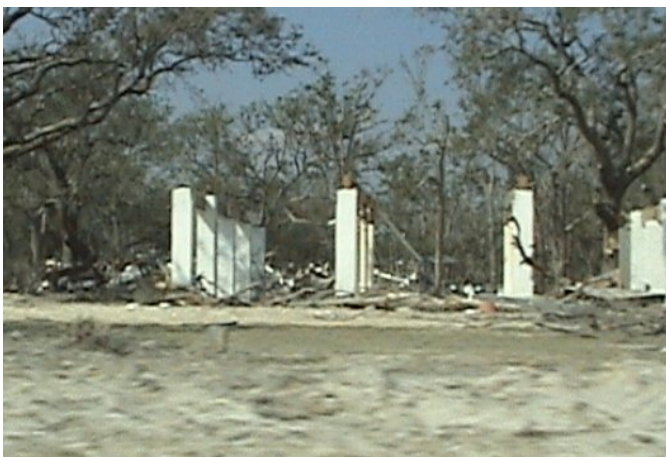
As a rule, light-frame wood structures along the coastline were almost entirely destroyed. The typical remains of coastline residence is shown in Fig. 26, where sub-structural columns (often made of heavy-timber or RC) survived but the supported house did not. Unfortunately, large numbers of images such as this line the Mississippi coast. Primary failures were at the nailed connections, as searching through debris piles revealed that most of the wood members

Figure 26. Typical remains of wood structure, where only pier system survived.

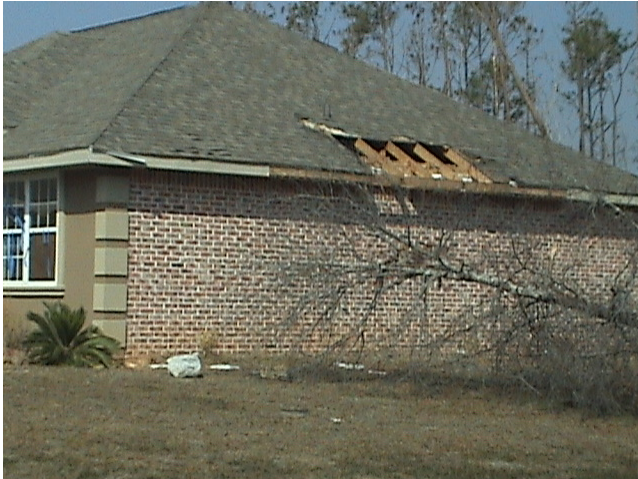
1. Roof failures. This generally occurred away from the coastline where the water surge was not great enough to topple the structure. As expected, roof damage typically occurred near the edges rather than central portion of the roof, where uplift forces are highest. The sheathing panels appeared to have lifted whole from the roof, indicating a lack of connection strength rather than panel bending capacity. Figure 27 presents a commonly-observed type of roof sheathing failure. This observation was experimentally verified as well (Schiff et al., 1996). Higher winds produced more extensive damage to the roof structure itself, which was also frequently observed (Fig. 28.)

Figure 27. Typical wood roof sheathing failure. Note panel is removed whole and at roof edge.

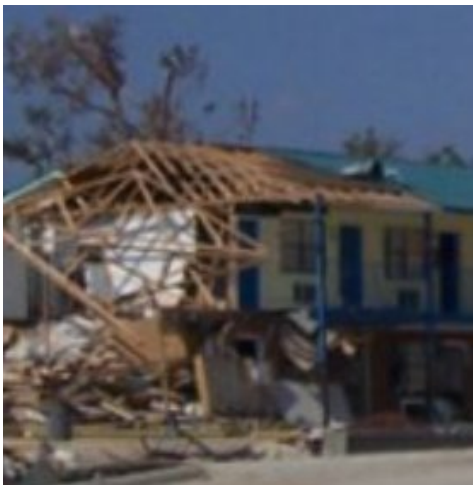
Figure 28. Typical wood roof structural system failure.

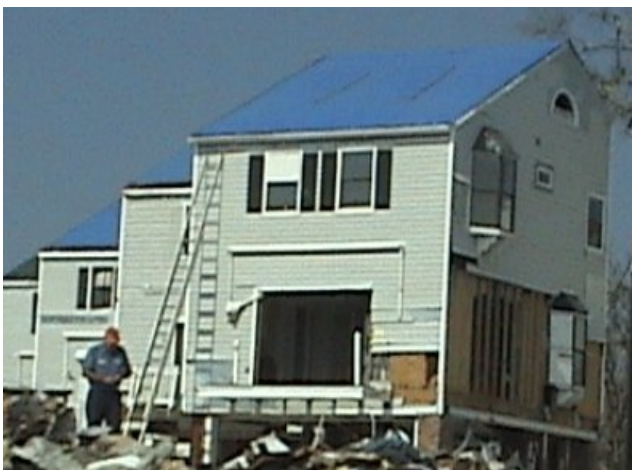
2. Siding and wall sheathing failures. As noted previously as being common on steel frame and RC frame buildings as well, siding and sheathing stripped from the structure is primarily a sign of wind damage (Fig. 29), though more extensive damage to sheathing may indicate high water loads. Again, most losses of siding are indicative of insufficient fastener strength.

Figure 29. Typical wood roof siding and sheathing failure.

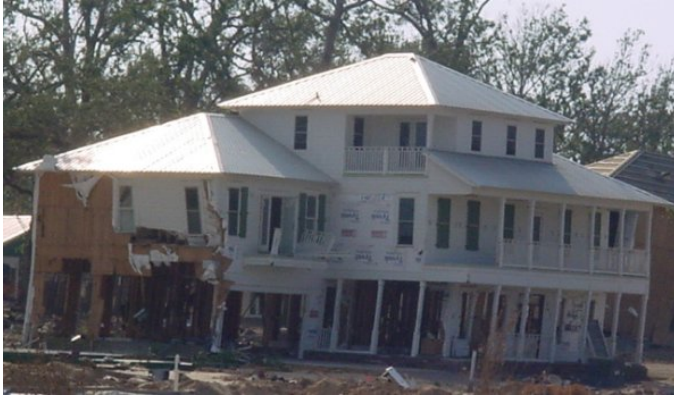
3. Side-sway failures. Figure 30 is representative of this type of failure. Of the three general types of light-frame wood structure failures observed, these were much less common than the other two outlined above. The loss of lateral stability could have been induced either by a wind or storm surge overload.

Figure 30. Wood house side-sway failure.

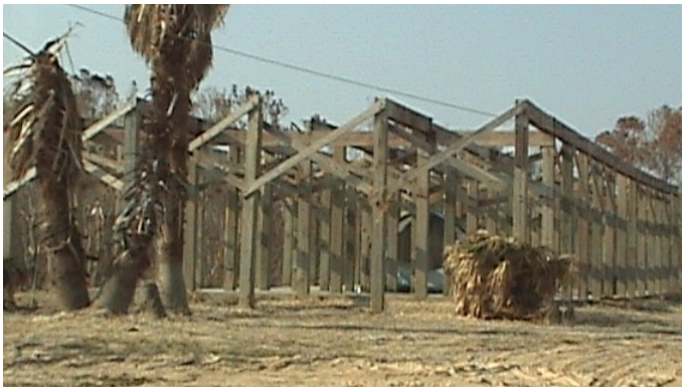
bolted) and member stiffness are much greater than those associated with the dimensional lumber in light-frame construction. Common timber structural systems that survived were post-and-beam pier substructures used to support a light-frame wood house above (Fig. 31.) Other structures included docks (Fig. 32) and glued-laminated frames (Fig. 33.) Although damage was observed on some of these systems, in general it appeared to be minimal.

Figure 31. Typical timber beam and pier system.

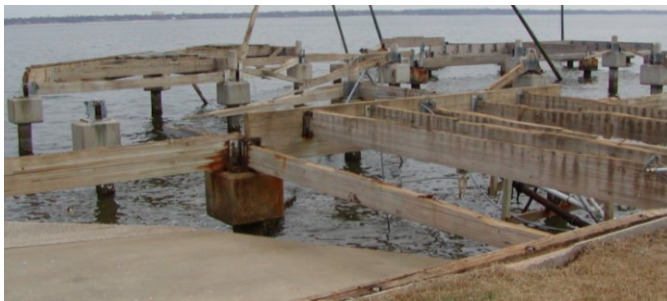
Figure 32. Survived glued-laminated dock.

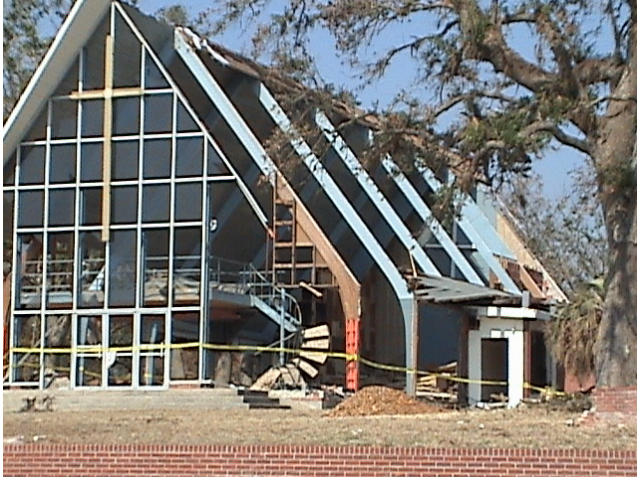
Figure 33. Survived glued-laminated frame.

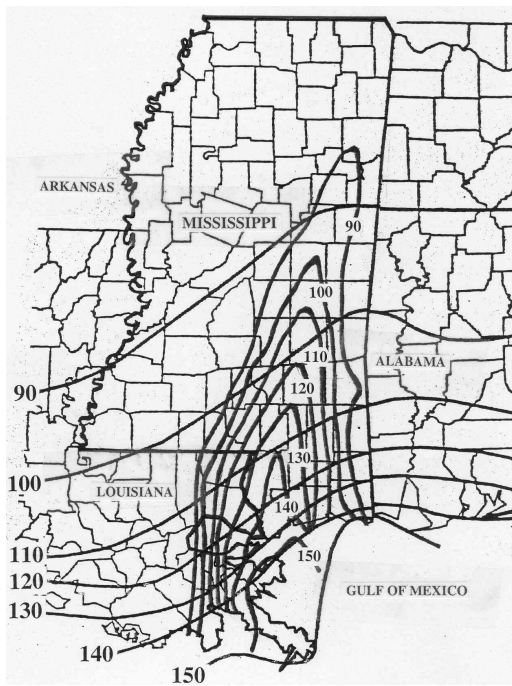
Figure 34 shows superimposed ASCE 7 basic design wind speed gusts to wind gusts estimated for Hurricane Katrina. The Katrina wind gusts were estimated by numerical simulation from the National Oceanic and Atmospheric Administration (NOAA) Atlantic Oceanography and Meteorology Lab H*Winds models, as well as in situ data collection (White et al. 2006.) Wind data collected from weather stations generally revealed lower gust speeds than the NOAA estimate, as shown in Table 3. The estimates are within reasonable agreement, however. As shown in Figure 34, the design winds are exceeded in a relatively narrow swath of land in the southeastern portion of the state. The maximum difference between the estimated Katrina wind speeds and the design wind speed is approximately 13 m/s, and occurs just south of the 49 m/s wind design speed contour, where the peak of the estimated 63 m/s wind gust contour appears. Based on the example residence above, assuming a 20 degree (approximately 4:12 pitch) gable roof in typical exposure C topography with importance factor 1.0, design wind pressures (unfactored) are given in Table 4 for a 49 m/s and 63 m/s wind. Values are computed using Method I in ASCE 7, a simplified analytical procedure. Considering both the main wind

resisting structural system as well as components and cladding, the Katrina-estimated 63 m/s wind is expected to apply lateral pressures of approximately 1.6 times those of the 49 m/s design wind.

Figure 34. Code (horizontal contours) and Katrina (vertical contours) wind gusts (MPH).
